Casa Vista Air Exhaust in “A” unit and “B” unit laundries

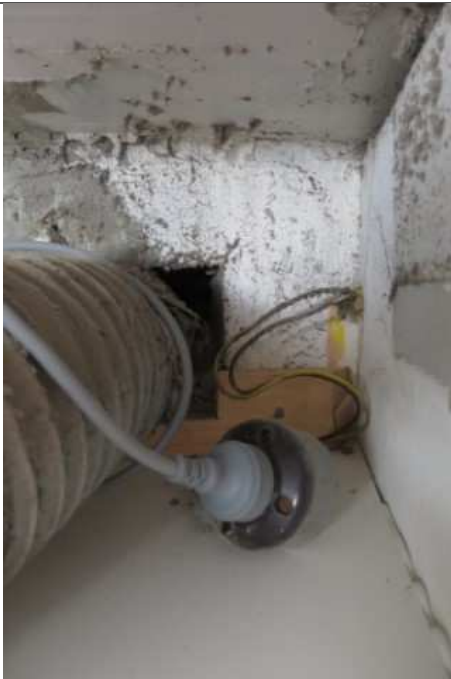
Exhaust grille on “A” balcony	Grille removed, flap up	“A” and “B” inlets visible and separator

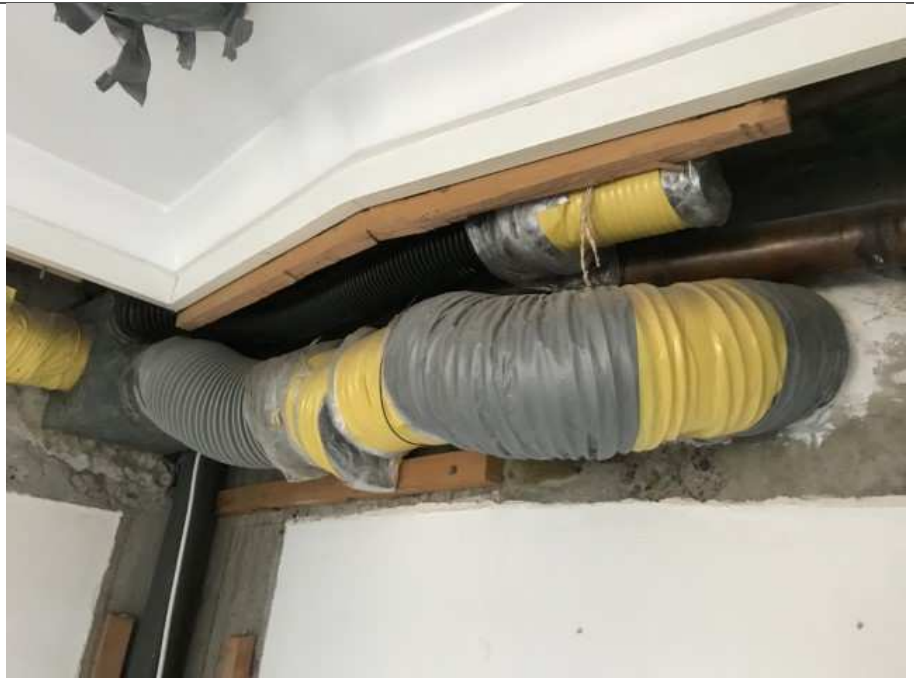
"A" unit flexi duct into "B" laundry

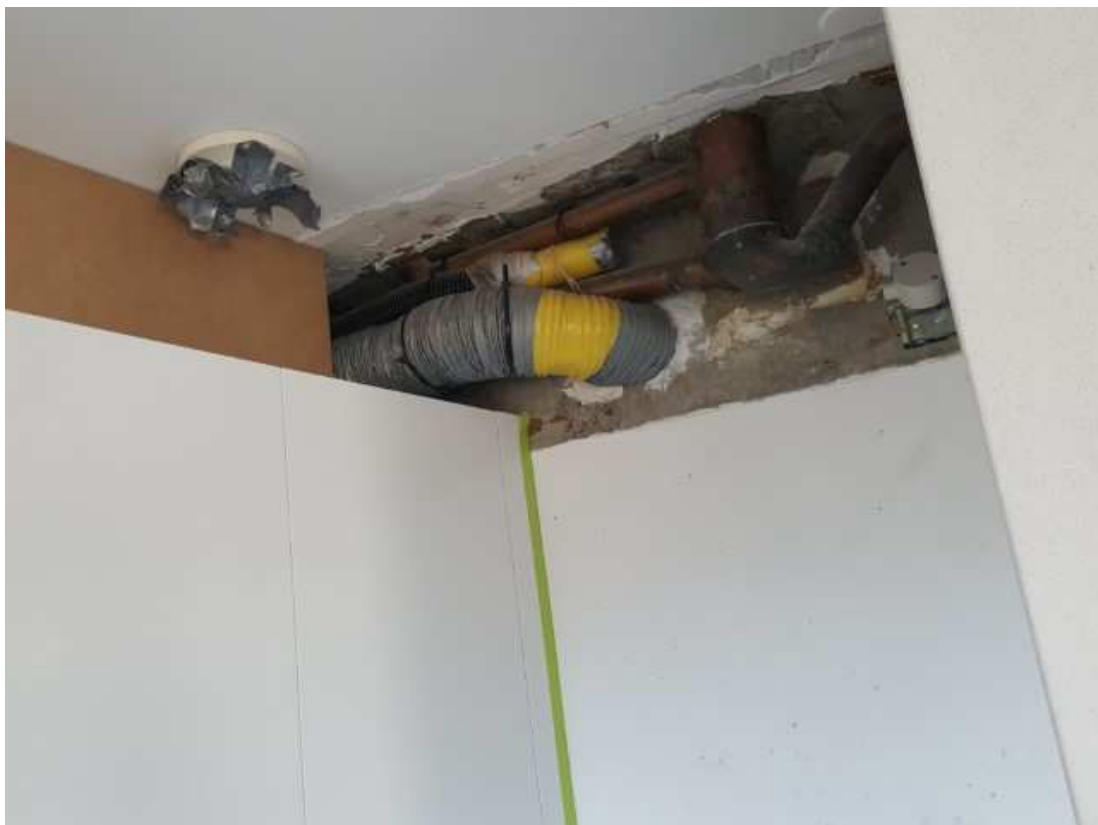
"B" laundry. Plenum chamber on left, "A" exhaust duct. See Note 1 below.

Note 1. The upper, smaller, flexible ducting is not seen in all units and appears to connect to the "A" side of the plenum chamber. It may be an unauthorized variation.

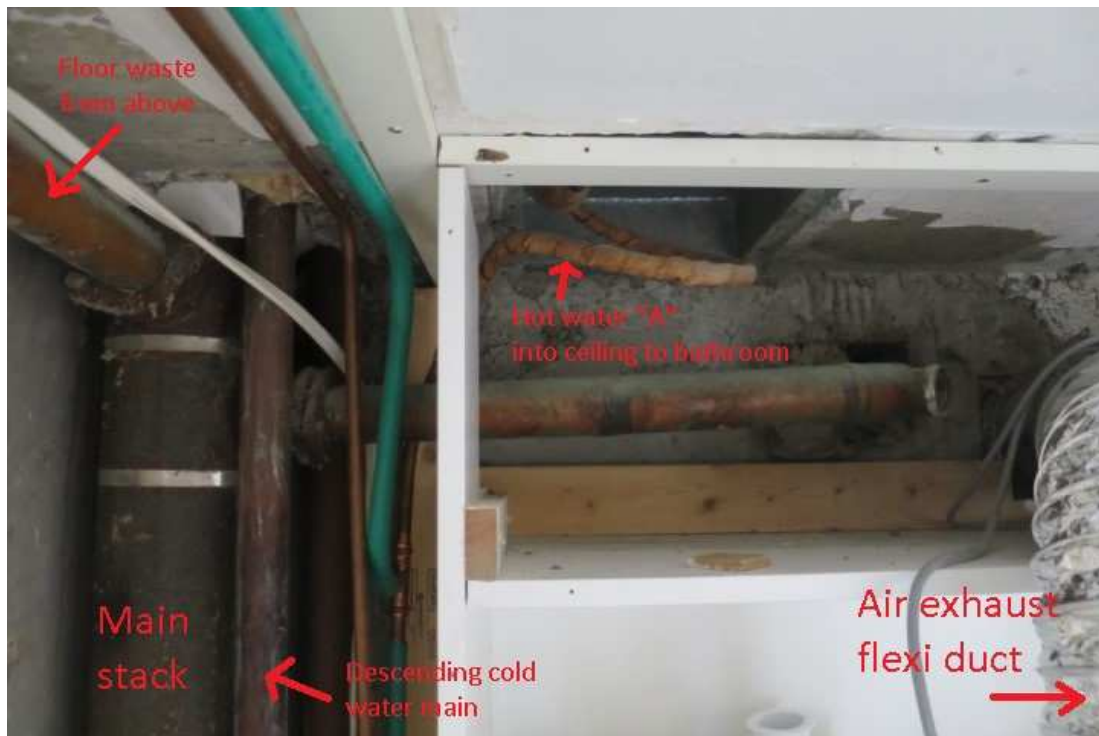
Another view in the "B" laundry showing also the above laundry washing machine drain (top copper pipe) and floor waste (large P trap). The lower copper pipe appears to drain through the wall into the "A" laundry and into the stack. (See below).
